Identifying Deliberate “Hail” and “Wind” Damage to Shingle Roofs

By Lyle D. Hogan, RRC, FRCI, PE

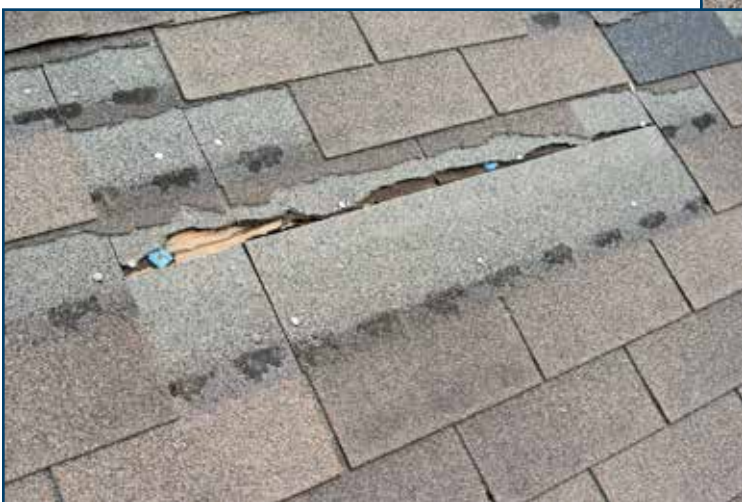
Figure 10 – Natural linear folding/creasing that constitutes legitimate roof damage. Note also the “graying-out” of the crease, suggesting this tab has been flexing in the wind for some time.

(Figure 10) represents legitimate compromise to a shingle roof; folding and creasing elsewhere on the tab exposure is a dubious occurrence. A casual Internet search will reveal the common manner of wind influence on shingles.

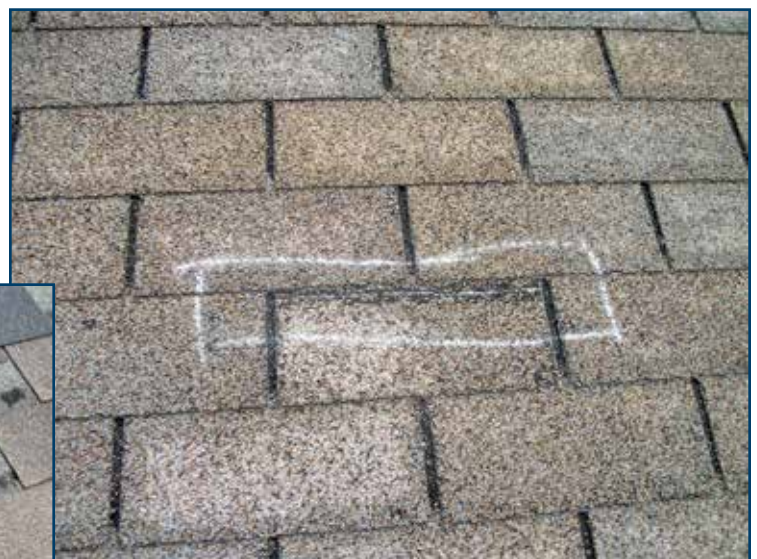
Figure 9 – Unnatural tear pattern from deliberate destruction.
